Structural Integrity Assessments (SIAs) of 27 Government Facilities Loan/Grant No.: 3877/OC-JA; GRT/ER-16412-JA

# University Hospital of the West Indies

October 2021

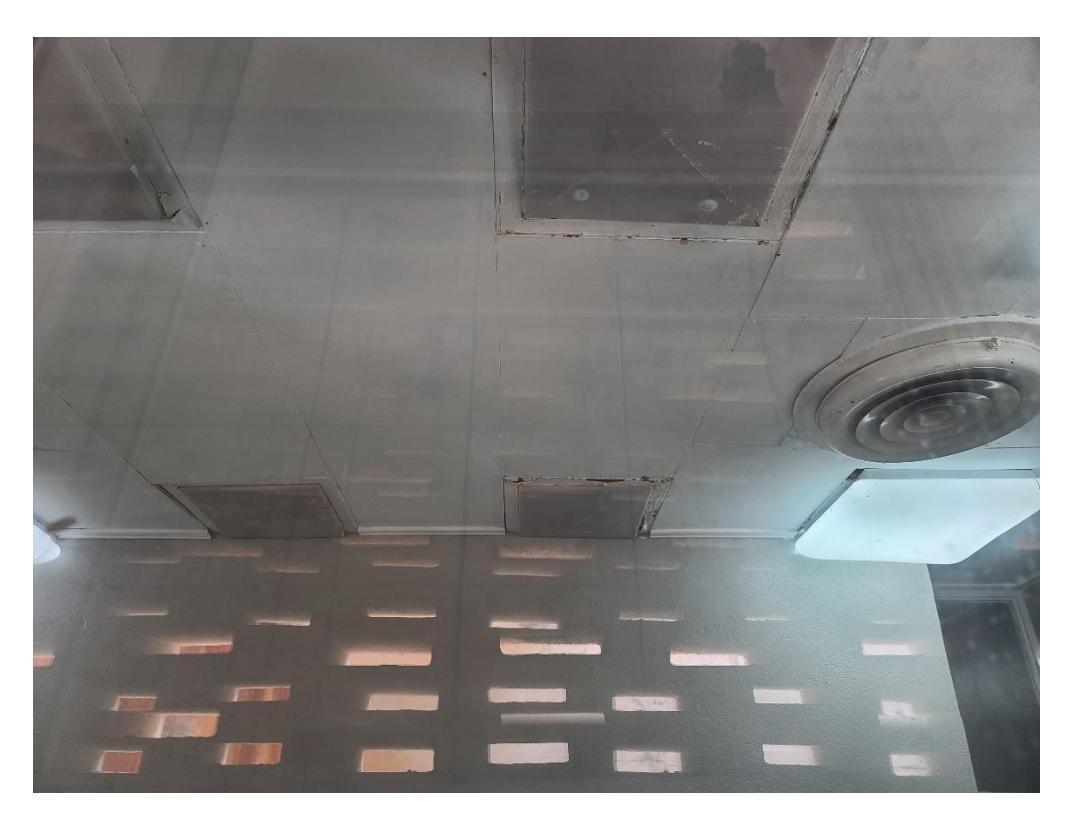
Image 29: Showing Operating Theatre 1-5 Ceiling.

The general condition of the Operating Theatres 1-5 is Fair. The building showed no adverse signs of deterioration or wear to the structurally relevant components. The walls showed moderate signs of deterioration and wear in the form of microcracks scattered throughout the structure which appeared to be mainly superficial. There were signs on water intrusion on the underside of the roof slab in one area. The suspended ceiling had light signs of wear and deterioration in some areas. Limited access was granted to some areas due to sensitive operations of the hospital. Thus, a thorough inspection of the roof's soffit was not possible in these areas. These observations are further illuminated in Appendix A – Photos. The salient information is shown in Table 4: Findings for the Operating Theatres 1-5 Roof below.

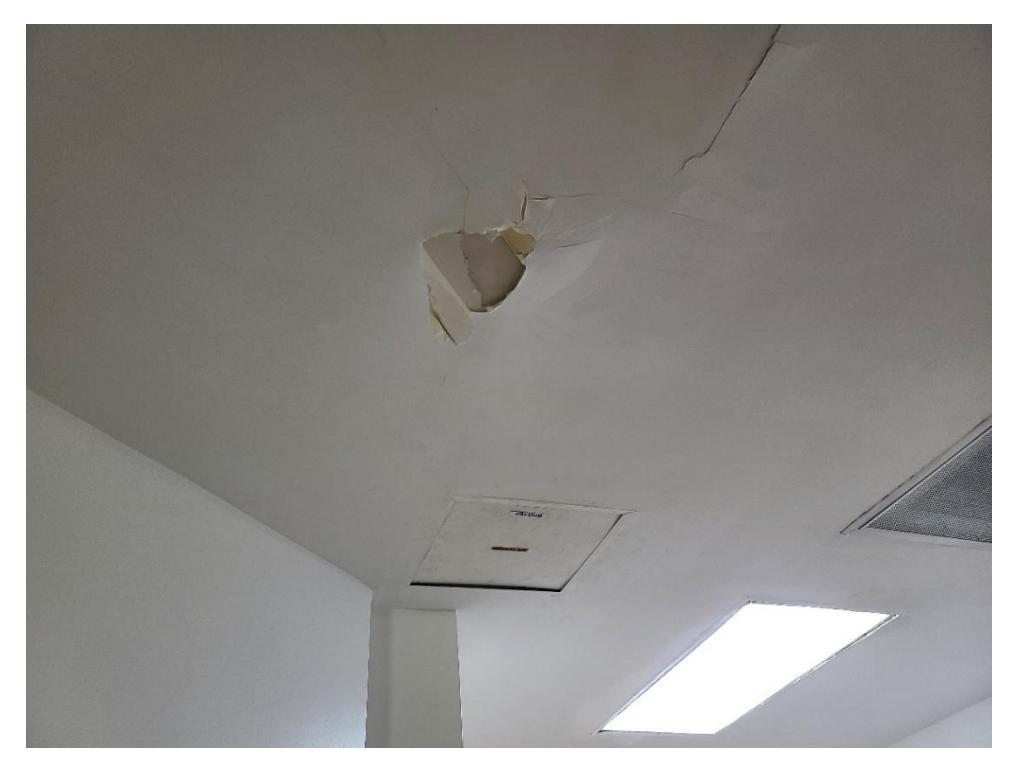
Image 31: Showing Damage to the ceiling of ICU B.

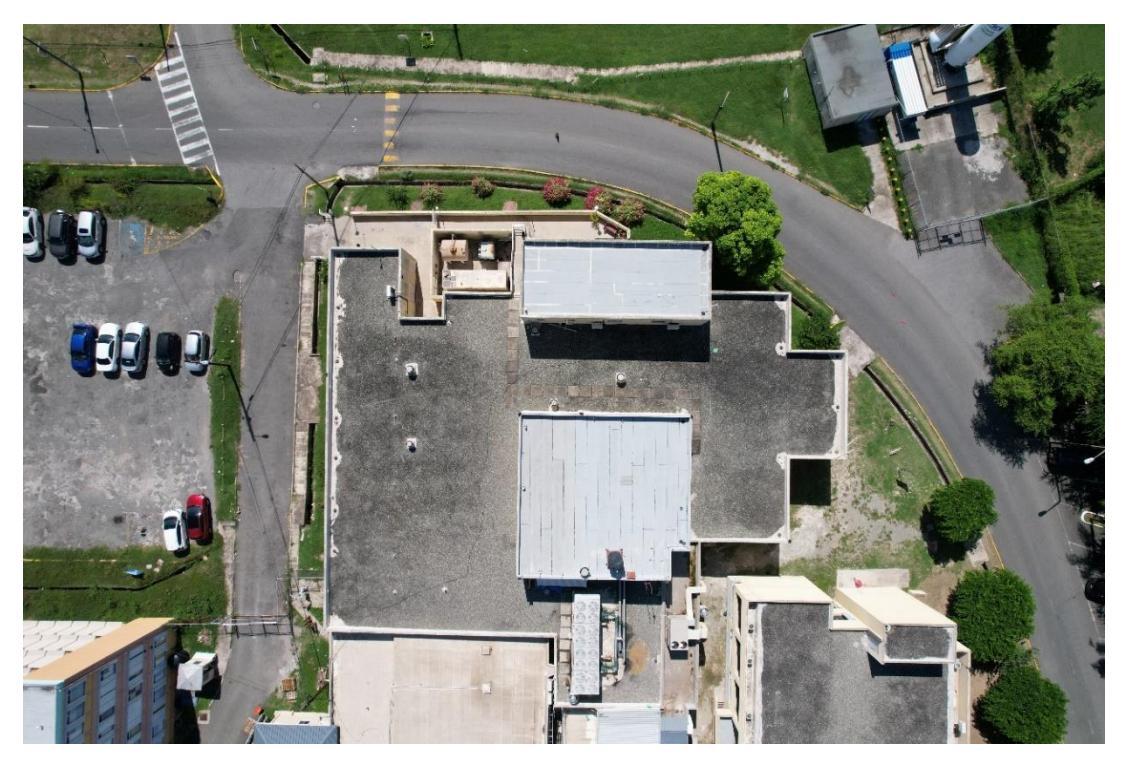
Image 32: Showing ICU B roof

The Surgical ICU (ICU B) & Operating Theatres 6-7 building is in poor condition. The building showed severe signs of deterioration and wear in the form of cracks scattered throughout the structure. The roof showed signs of water intrusion from the underside. In Ward 1, though no cracks were seen, there was ponding on the roof. Isolated locations of spalling could also be identified. The suspended ceiling showed moderate signs of deterioration. Advanced signs of wearing were observed at a section of the foam and aggregate roof waterproofing membrane. It was generally in fair condition. These observations are further illuminated in Appendix A – Photos. The salient information as well as a cursory depiction of the anticipated structural performance of the building roof is shown in Table 5: Findings for Surgical ICU (ICU B) & Operating Theatres 6-7 Roof below.

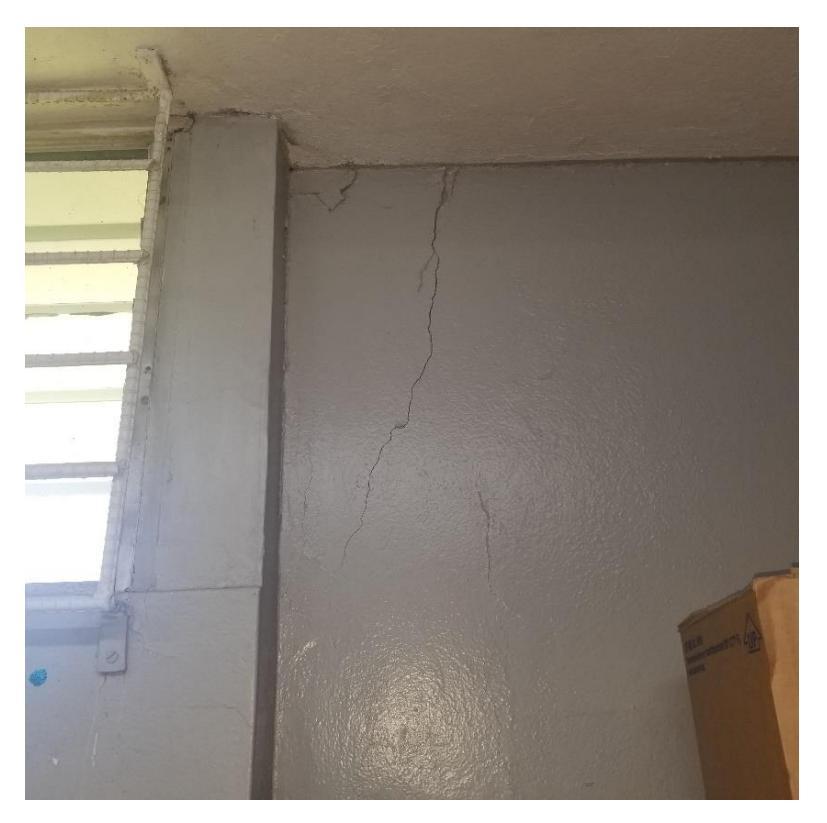
Image 55: Showing Crack in Wall at X-Ray

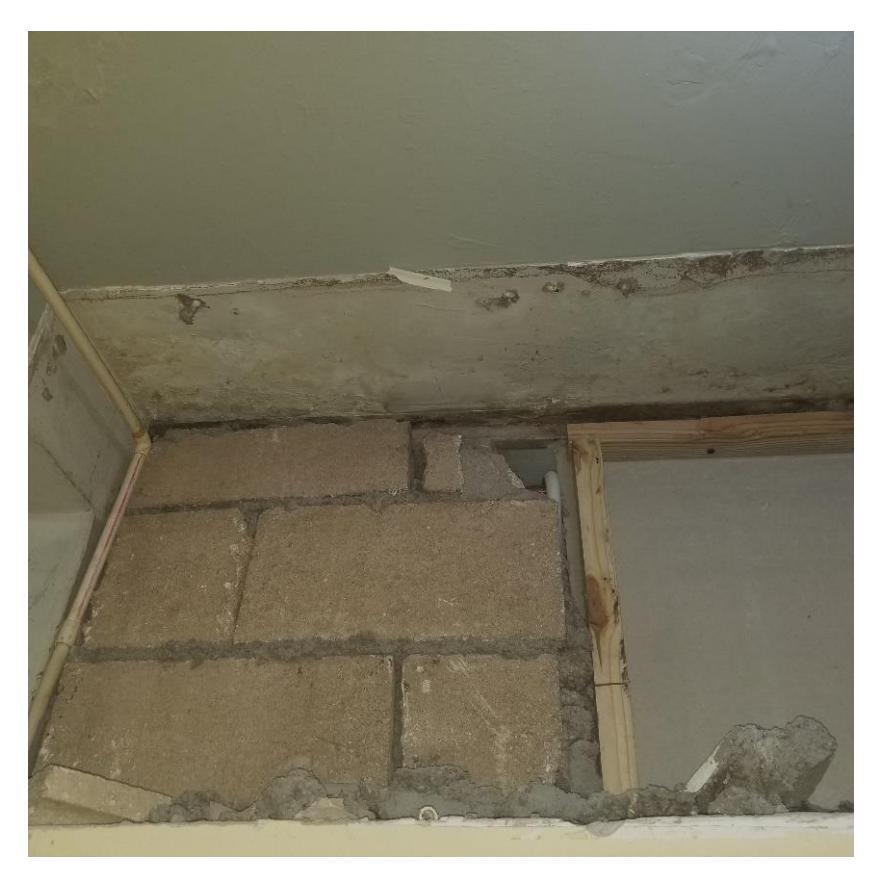
Image 56: Showing X-Ray Soffit

The X Ray/Catheterization/Ultrasound building is in Fair condition. The building showed moderate signs of deterioration and wear in the form of micro cracks scattered throughout the structure which appeared to be mainly superficial. One section however, showed a seemingly structural crack in the wall which was not far advanced. At the lower roof level of the building, spanning between the RC beams is a flat reinforced concrete slab and a timber framed gable roof, both covered with a sheet-based waterproofing membrane. At the upper roof level, the flat reinforced concrete slab roof is covered with a foam-based membrane with aggregate which showed signs of deterioration. These observations are further illuminated in Appendix A – Photos. The salient information as well as a cursory depiction of the Anticipated structural performance of the building roof is shown in Table 12: Findings for X Ray/Catheterization/Ultrasound Roof below. The information shown will focus on the slab sections of the roof, as the only sections seeming practical for consideration.

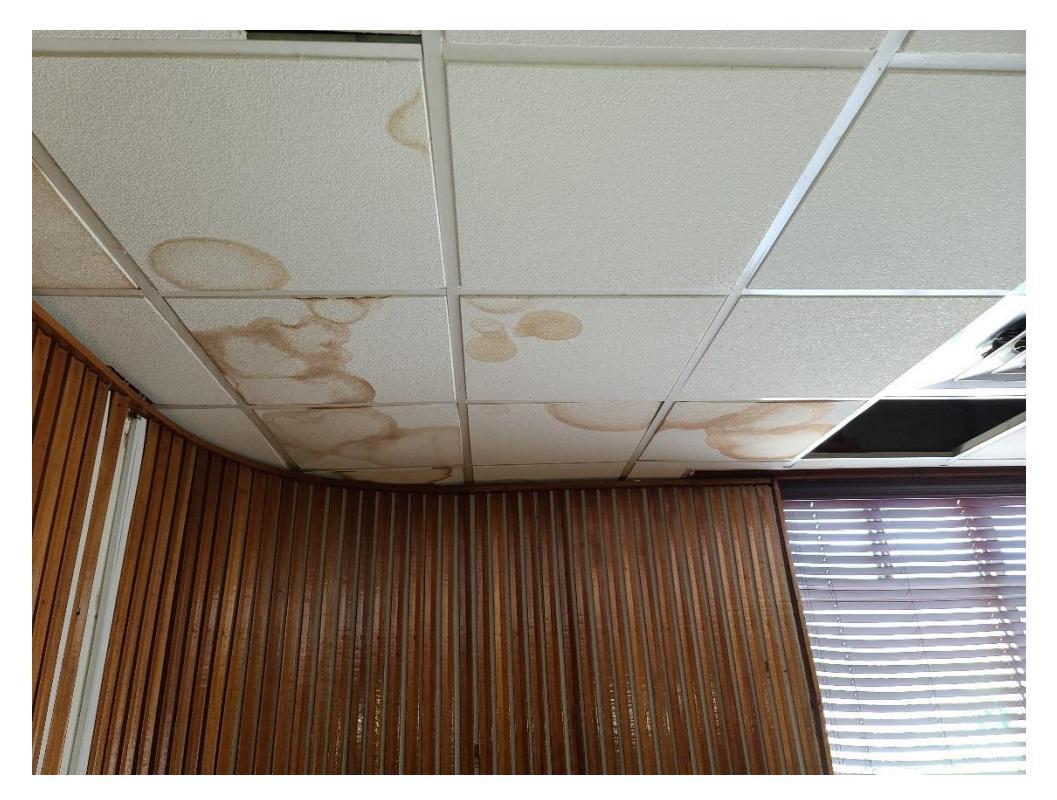
Image 63: Showing signs of leakage in Administration Building Ceiling

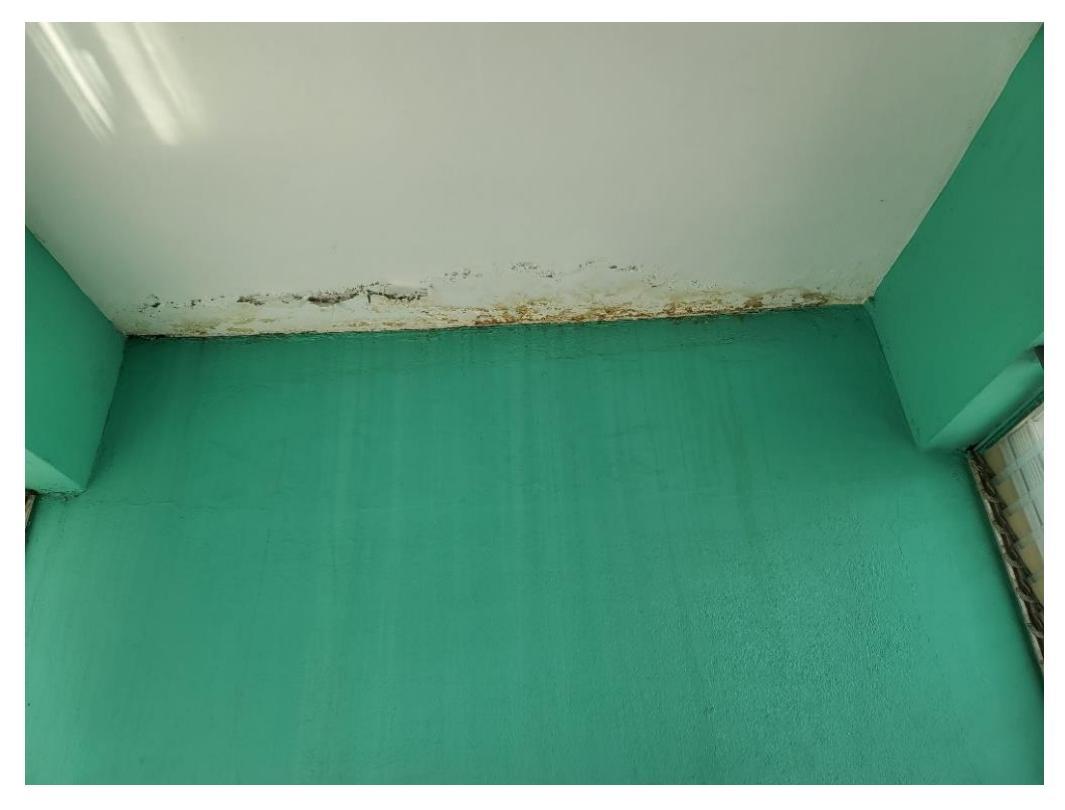
Image 72: Showing Damaged Soffit at Labour Ward
