Structural Integrity Assessments (SIAs) of 27 Government Facilities Loan/Grant No.: 3877/OC-JA; GRT/ER-16412-JA

# University Hospital of the West Indies

October 2021

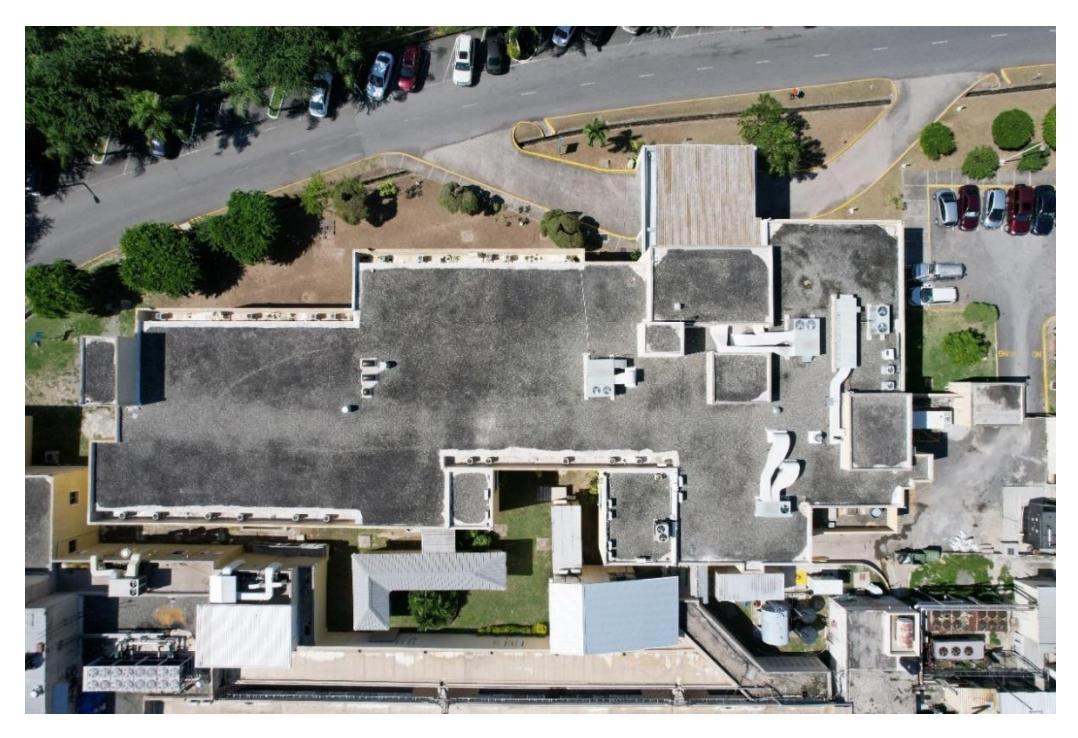
Limited access was granted due to sensitive operations of the hospital. Thus, a thorough inspection of the roof slab soffit was not possible. Notwithstanding, the general condition of Tony Thwaites Private Wing is Fair. The building showed no adverse signs of deterioration and wear throughout the structure. These observations are further illuminated in Appendix A – Photos. The salient information as well as a cursory depiction of the anticipated structural performance of the building roof is shown in Table 2: Findings for Tony Thwaites Private Wing Roof. below.

Image 21: Tony Thwaites Private Wing Building Roof.

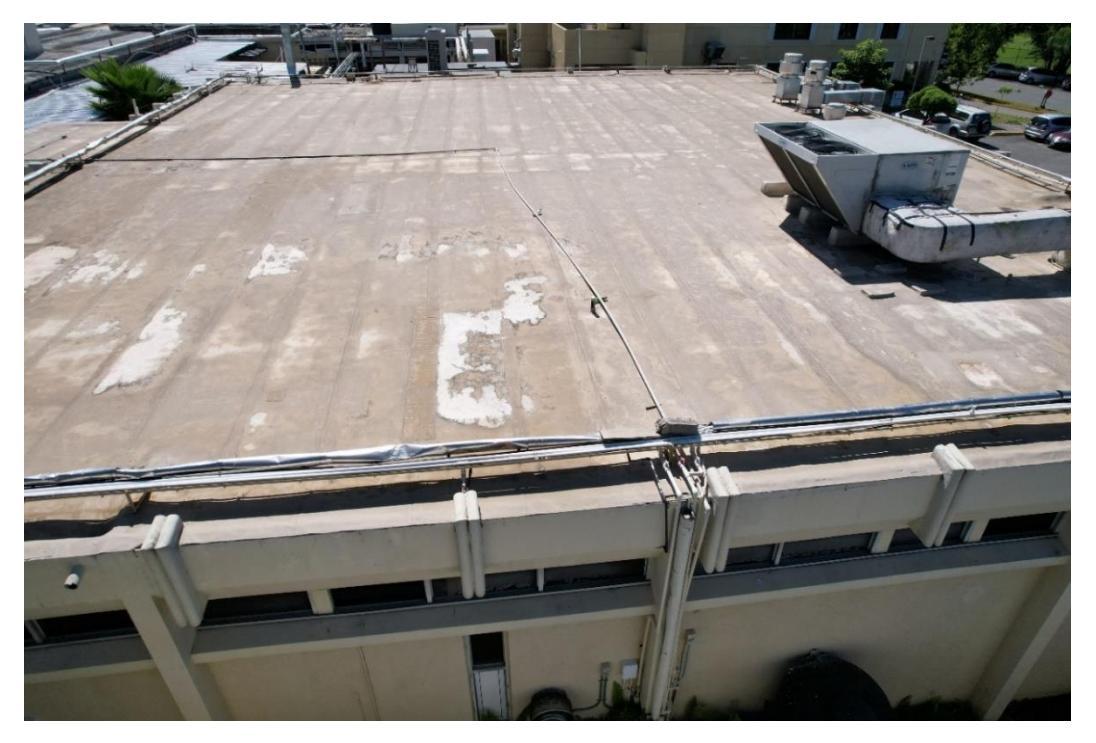
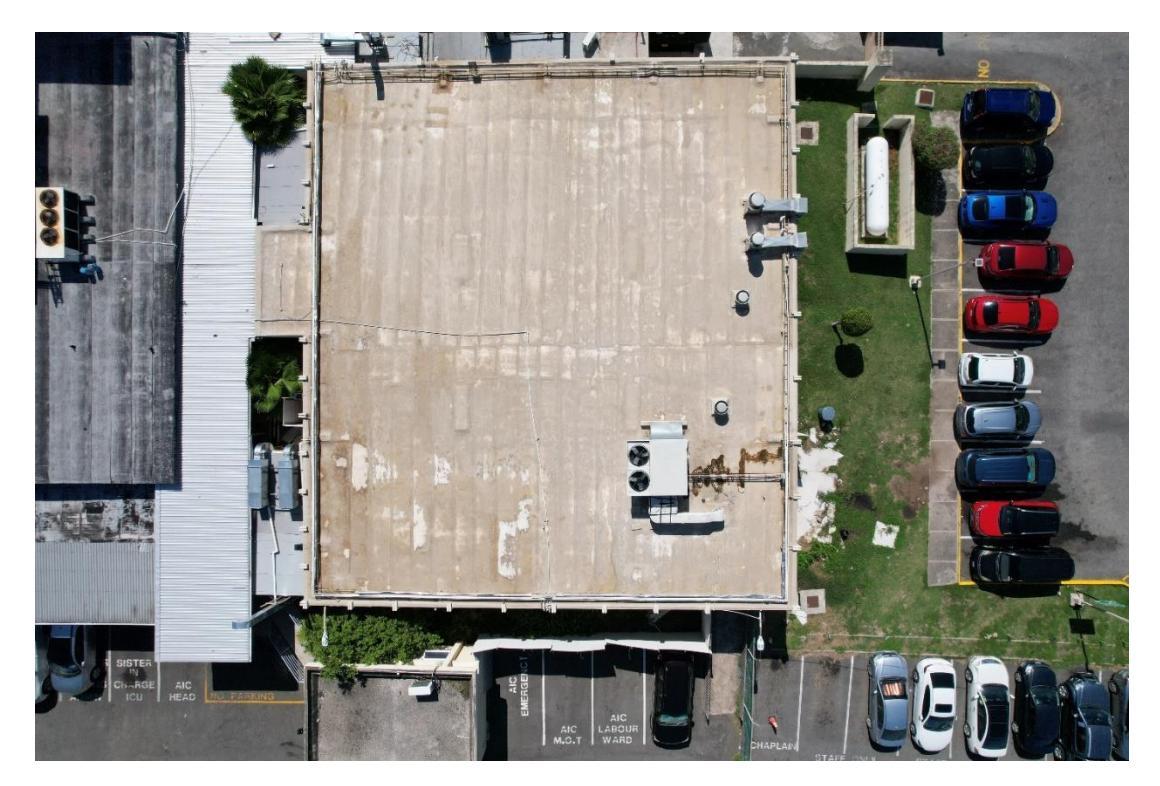
Limited access was granted due to sensitive operations of the hospital. Thus, a thorough inspection of the roof slab soffit was not possible. Notwithstanding, the general condition of ICU A is Fair. The building showed no adverse signs of deterioration and wear throughout the structure. Additionally, the suspended ceiling appeared to be in good condition. Access to the soffit of the roof slab, through the ceiling, was possible through a suspended ceiling tile that revealed a grid of reinforced concrete beams in good condition. These observations are further illuminated in Appendix A – Photos. The salient information as well as a cursory depiction of the anticipated structural performance of the building roof is shown in Table 3: Findings for ICU A Roof below.

Image 22: Showing ICU A roof.

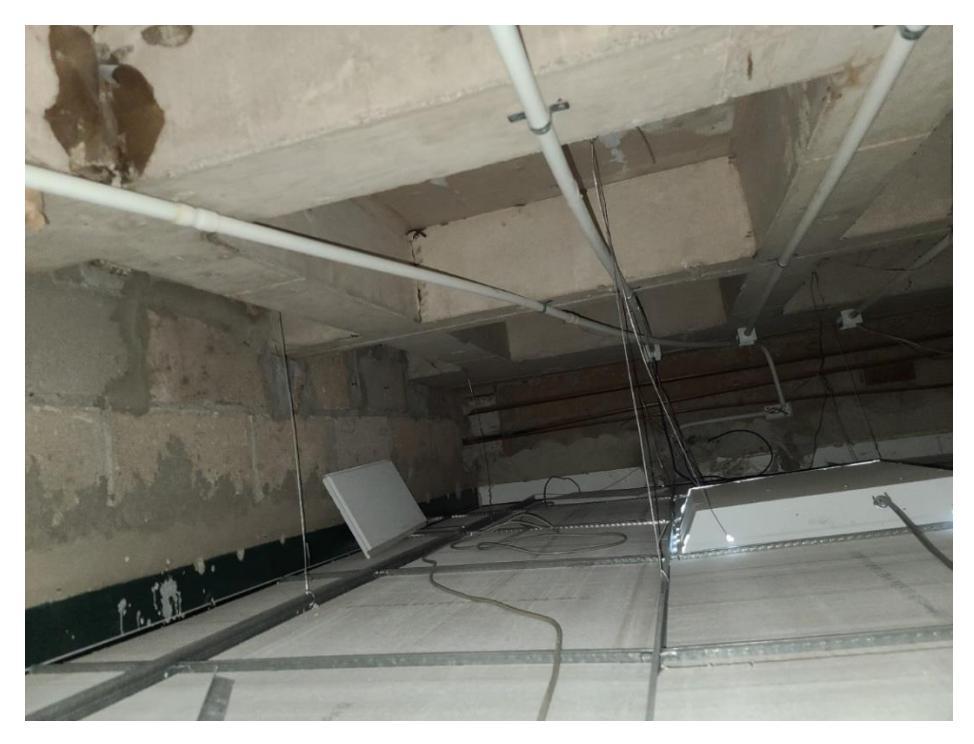
Image 24: Showing ICU A Roof Slab Soffit

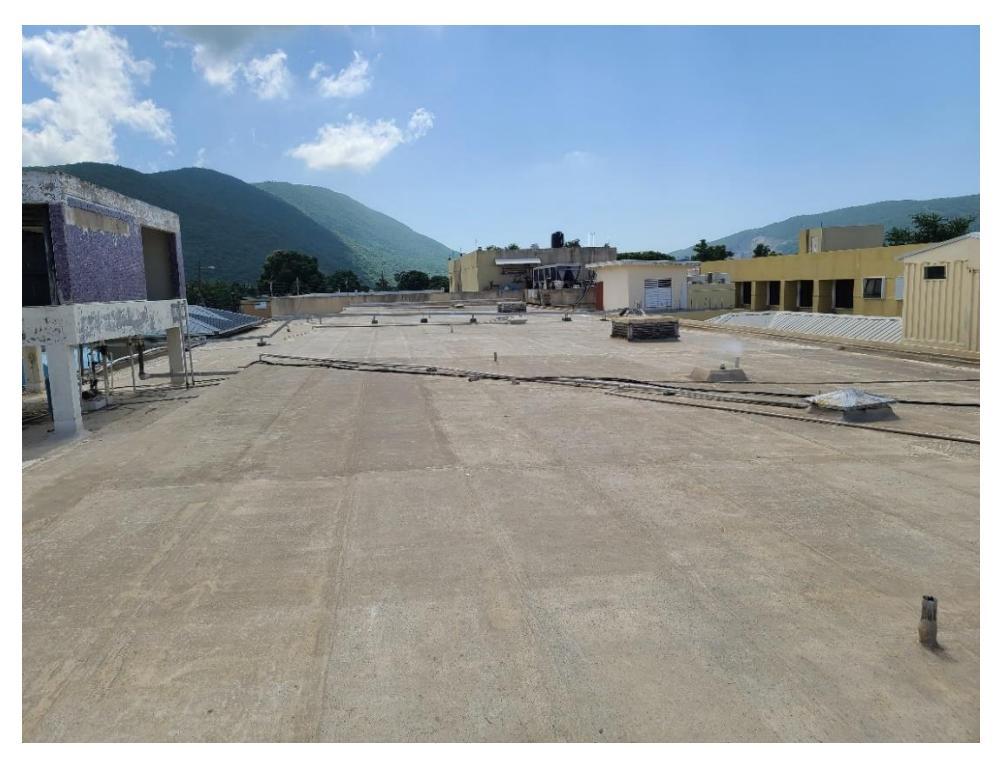
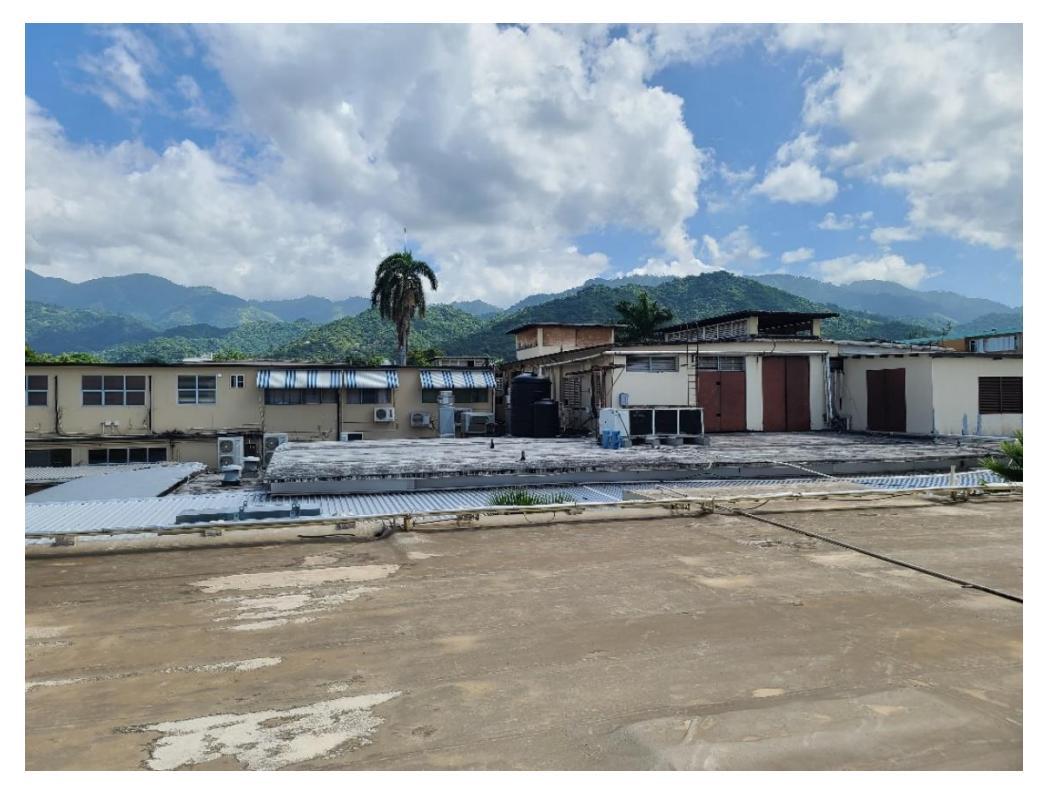
The general condition of the Operating Theatres 1-5 is Fair. The building showed no adverse signs of deterioration or wear to the structurally relevant components. The walls showed moderate signs of deterioration and wear in the form of microcracks scattered throughout the structure which appeared to be mainly superficial. There were signs on water intrusion on the underside of the roof slab in one area. The suspended ceiling had light signs of wear and deterioration in some areas. Limited access was granted to some areas due to sensitive operations of the hospital. Thus, a thorough inspection of the roof's soffit was not possible in these areas. These observations are further illuminated in Appendix A – Photos. The salient information is shown in Table 4: Findings for the Operating Theatres 1-5 Roof below.

Image 25: Showing Operating Theatre 1-5 Roof

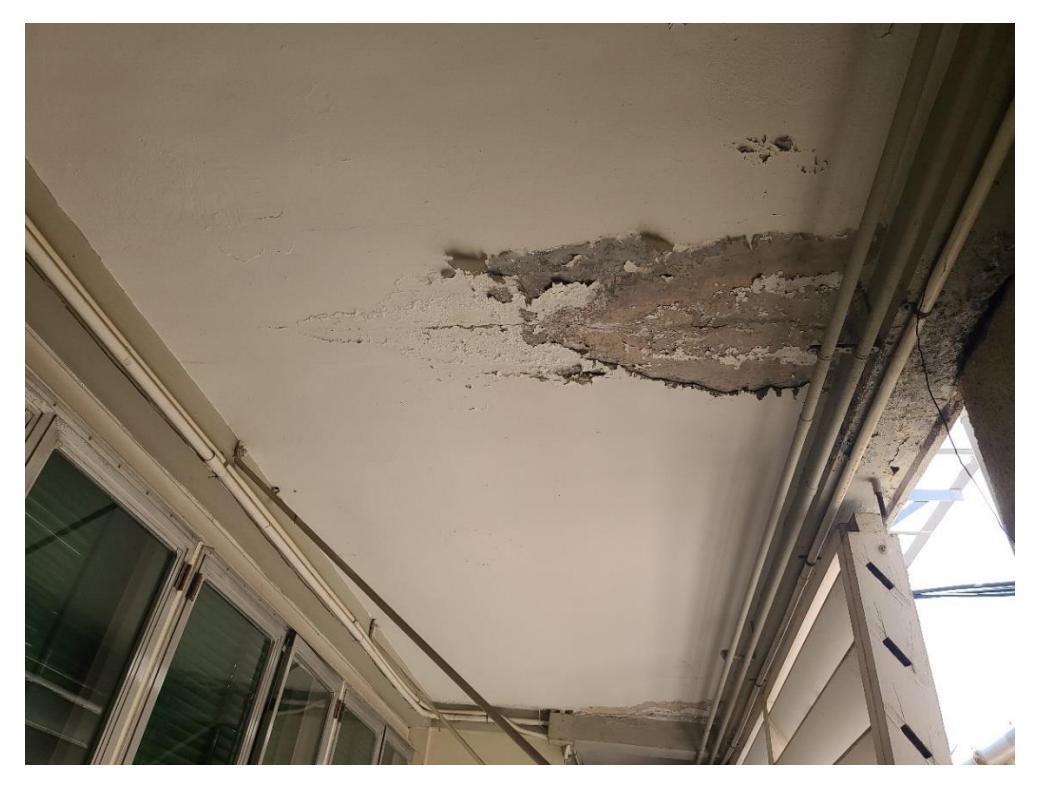
Image 26: Showing Operating Theatre 1-5 Walkway Soffit

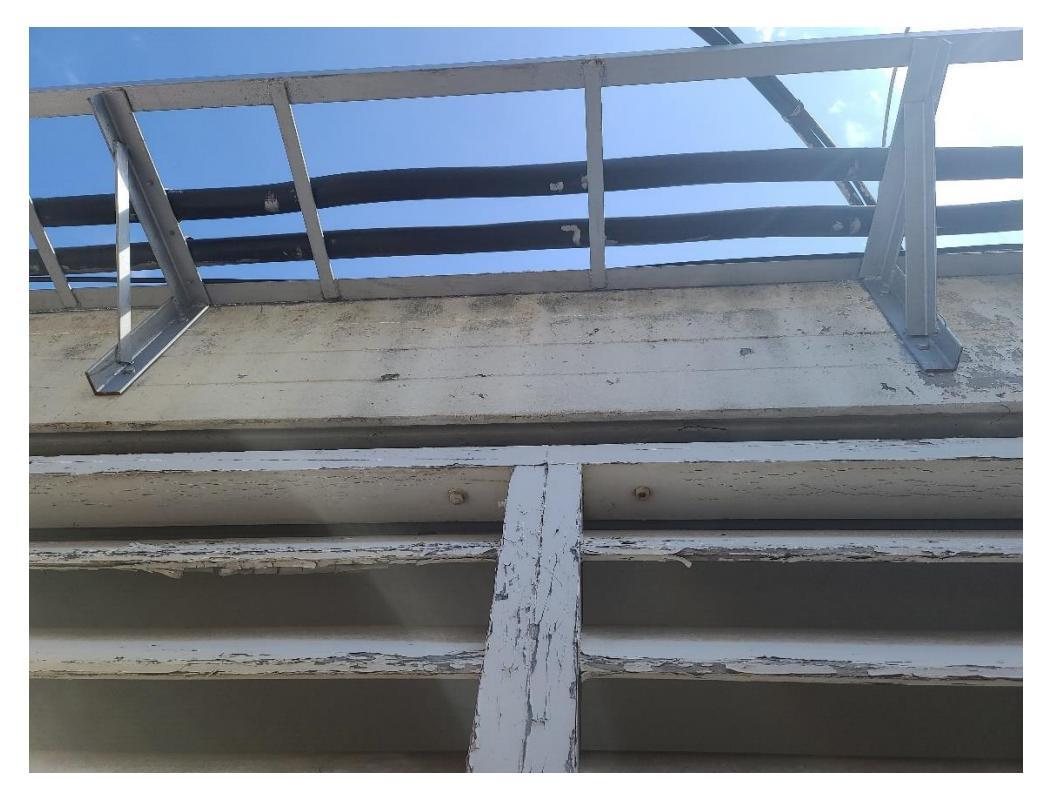
Image 27: Along external facade of Operating Theatres 1-5

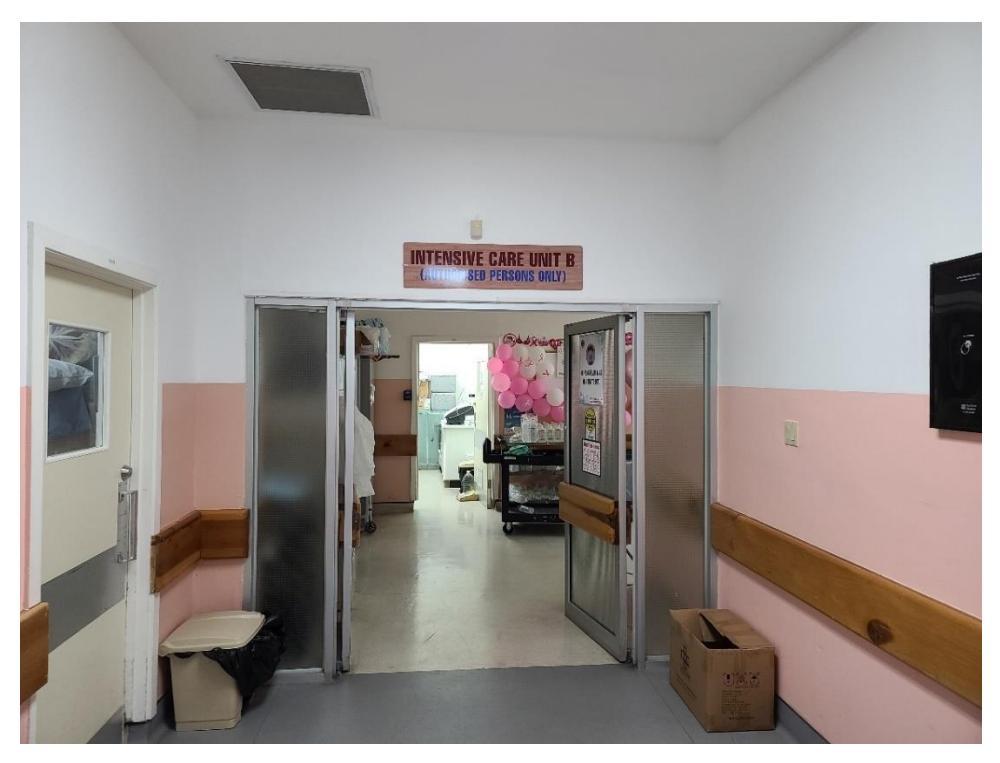
The Surgical ICU (ICU B) & Operating Theatres 6-7 building is in poor condition. The building showed severe signs of deterioration and wear in the form of cracks scattered throughout the structure. The roof showed signs of water intrusion from the underside. In Ward 1, though no cracks were seen, there was ponding on the roof. Isolated locations of spalling could also be identified. The suspended ceiling showed moderate signs of deterioration. Advanced signs of wearing were observed at a section of the foam and aggregate roof waterproofing membrane. It was generally in fair condition. These observations are further illuminated in Appendix A – Photos. The salient information as well as a cursory depiction of the anticipated structural performance of the building roof is shown in Table 5: Findings for Surgical ICU (ICU B) & Operating Theatres 6-7 Roof below.

Image 30: Inside of ICU B

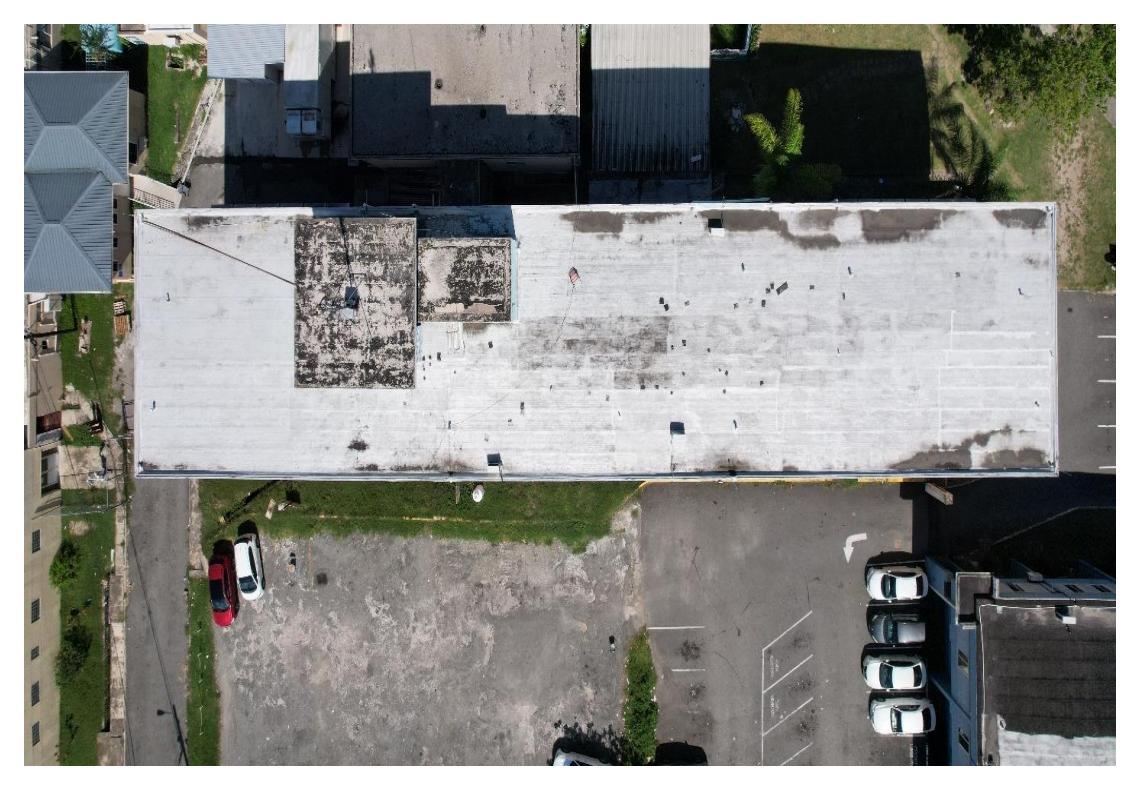
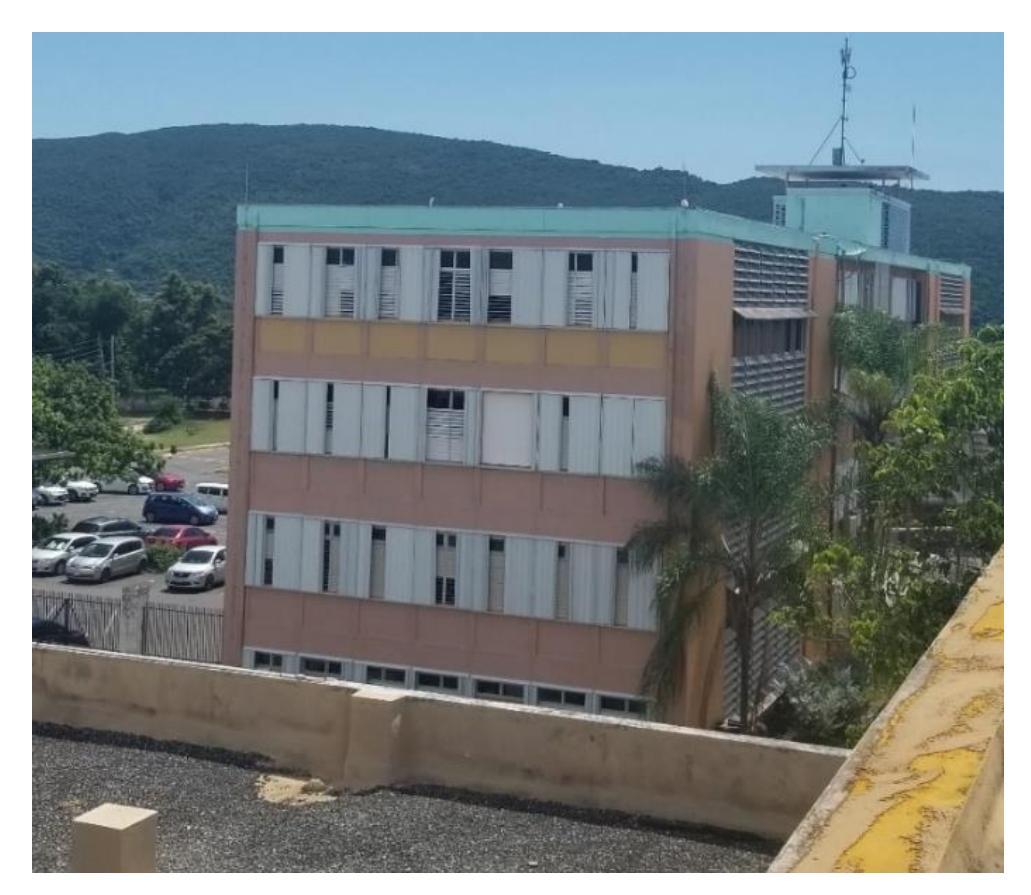
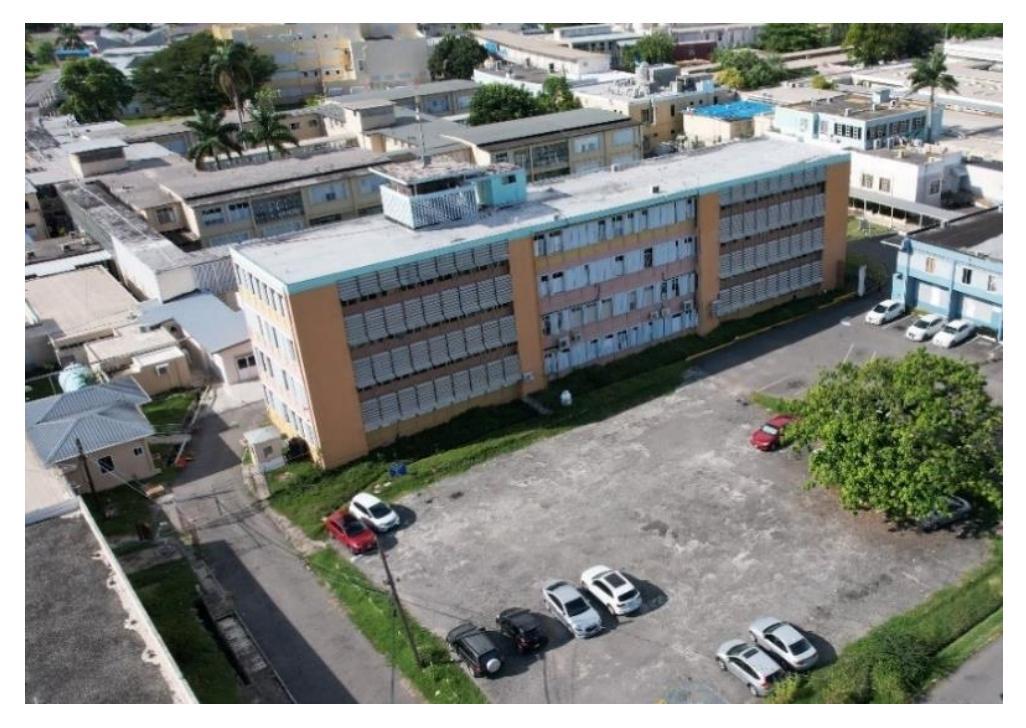
The Specialty Wards is in a fair condition. The building showed moderate signs of deterioration and wear in the form of micro cracks scattered throughout the structure which appeared to be mainly superficial. These observations are further illuminated in Appendix A – Photos. The salient information as well as a cursory depiction of the Anticipated structural performance of the building roof is shown in Table 6: Showing Findings for Specialty Wards Roof below.

Image 33: Showing Specialty Ward Roof

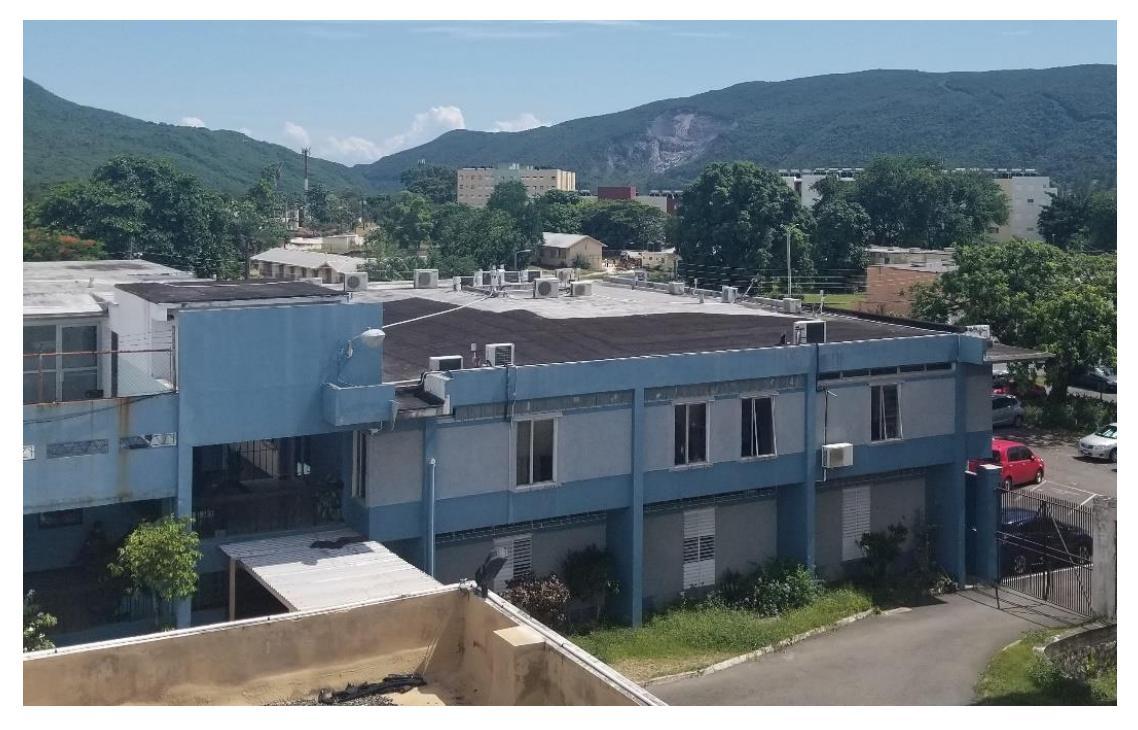
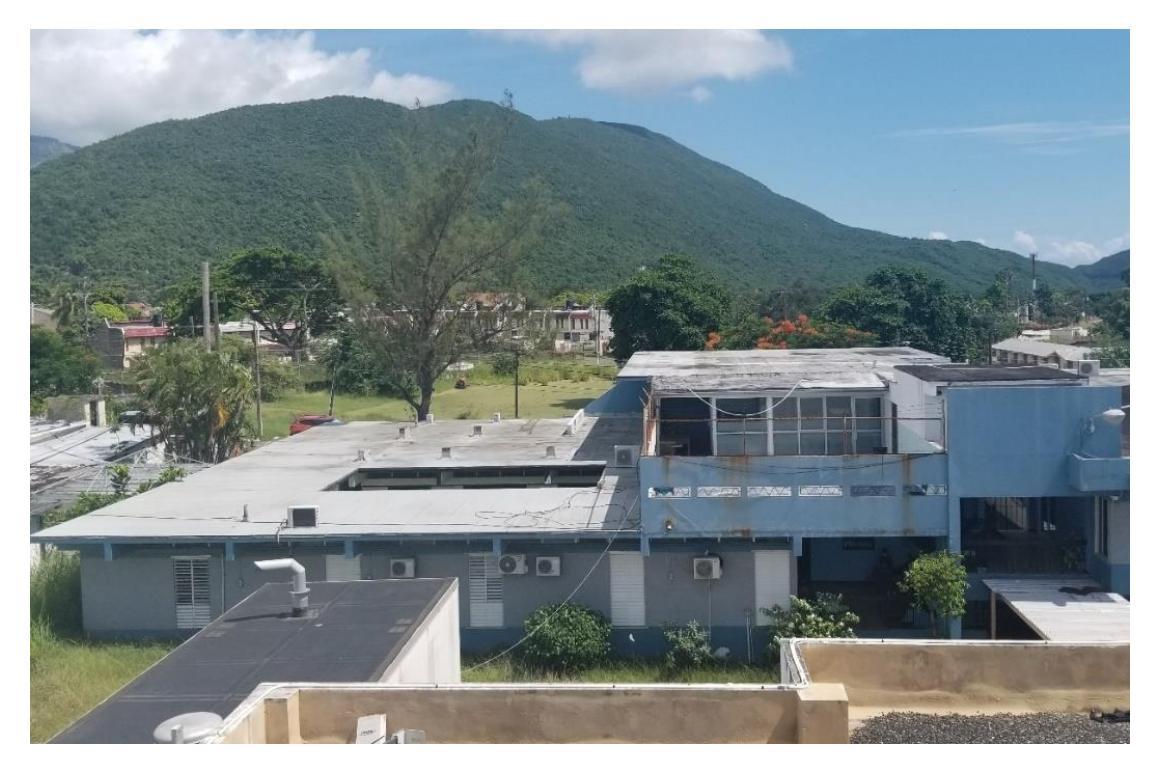
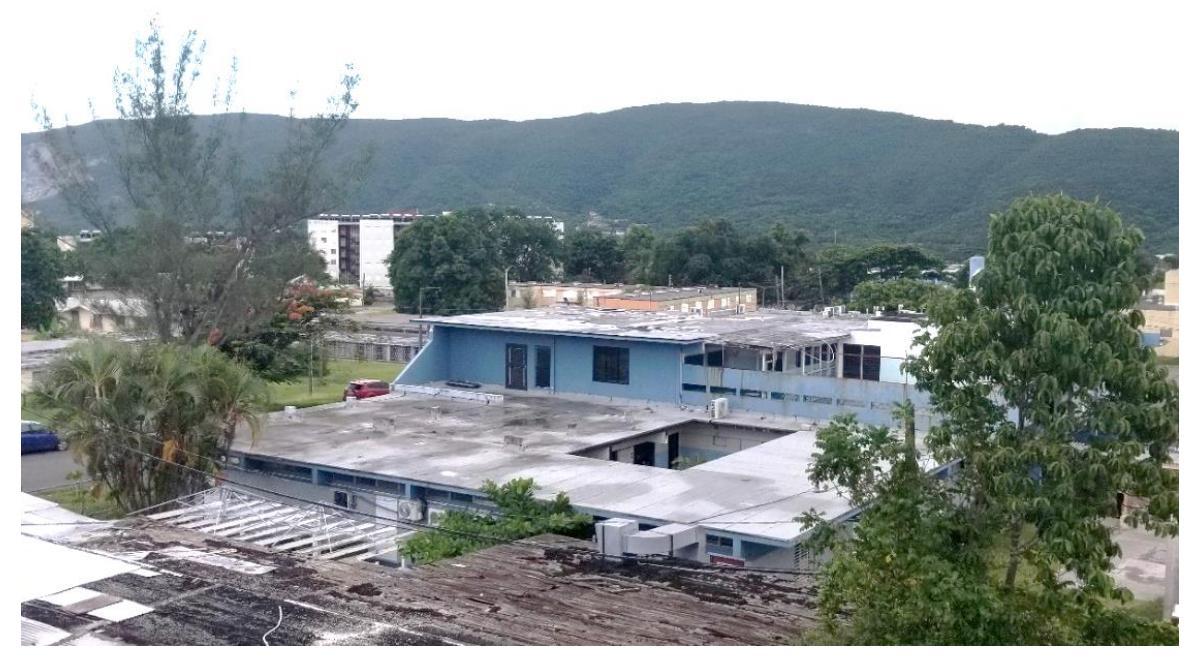
The Psychiatry Ward Building is in Fair condition. The building showed moderate signs of deterioration and wear in the form of micro cracks scattered throughout the structure which appeared to be mainly superficial. The waterproofing membrane was in fair condition. The roof of the single storey section has seemingly stub columns, indicating plans for future vertical expansion in that area. These observations are further illuminated in Appendix A – Photos. The salient information as well as a cursory depiction of the Anticipated structural performance of the building roof is shown in Table 7: Findings for Psychiatry Ward Roof below.

Image 37: Showing Psychiatry Ward Roof

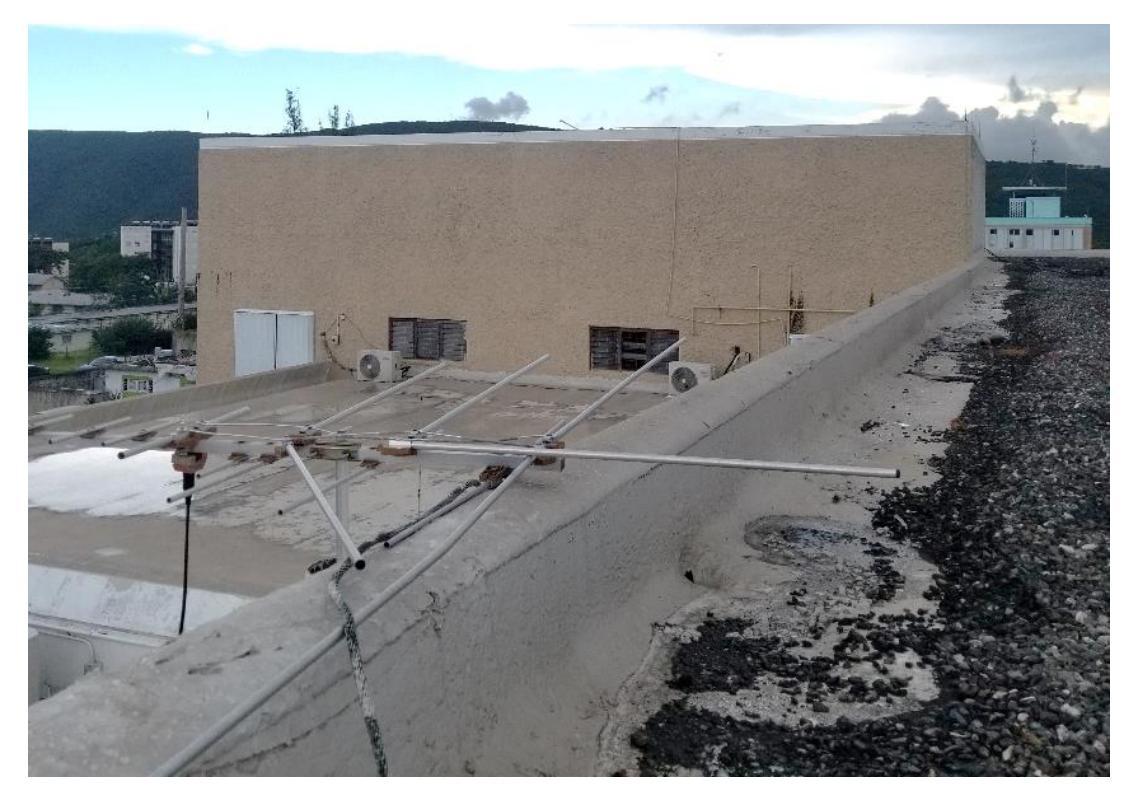
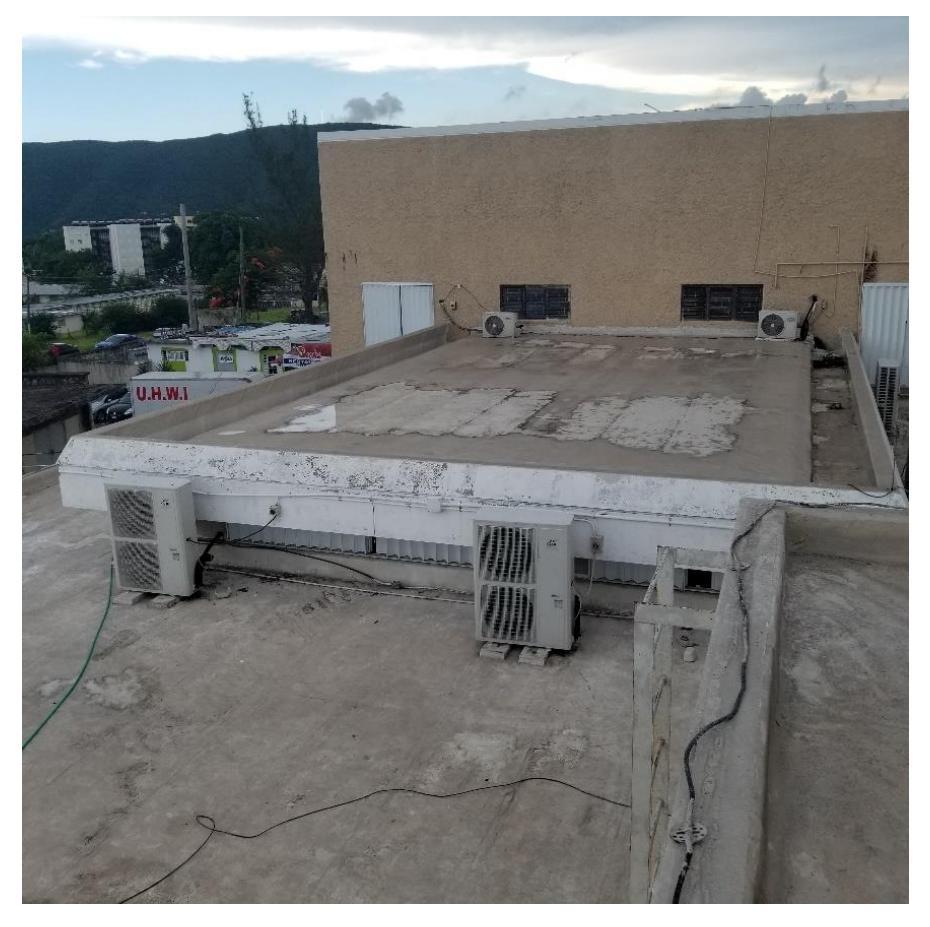
The Accident & Emergency appears to be in relatively good condition. The building showed moderate signs of deterioration and wear in the form of micro cracks scattered throughout the structure which appeared to be mainly superficial. The two roof levels were in fair condition, including the waterproofing membranes on each. These observations are further illuminated in Appendix A – Photos. The salient information as well as a cursory depiction of the anticipated structural performance of the building roof is shown in Table 8: Findings for Accident & Emergency Roof below.

Image 39: Showing Accident and Emergency Roof

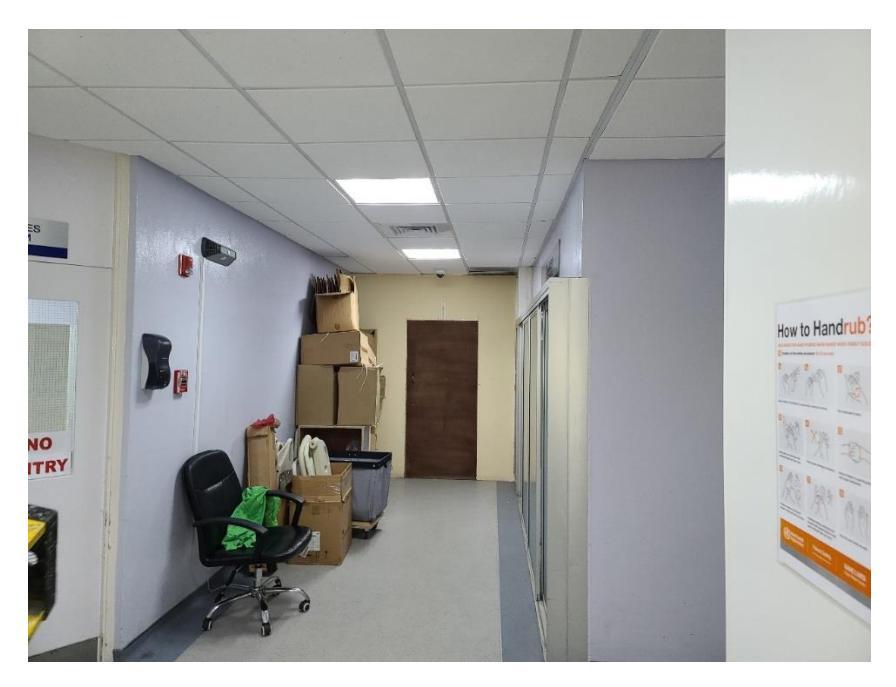
Image 41: Showing Accident and Emergency Ceiling.

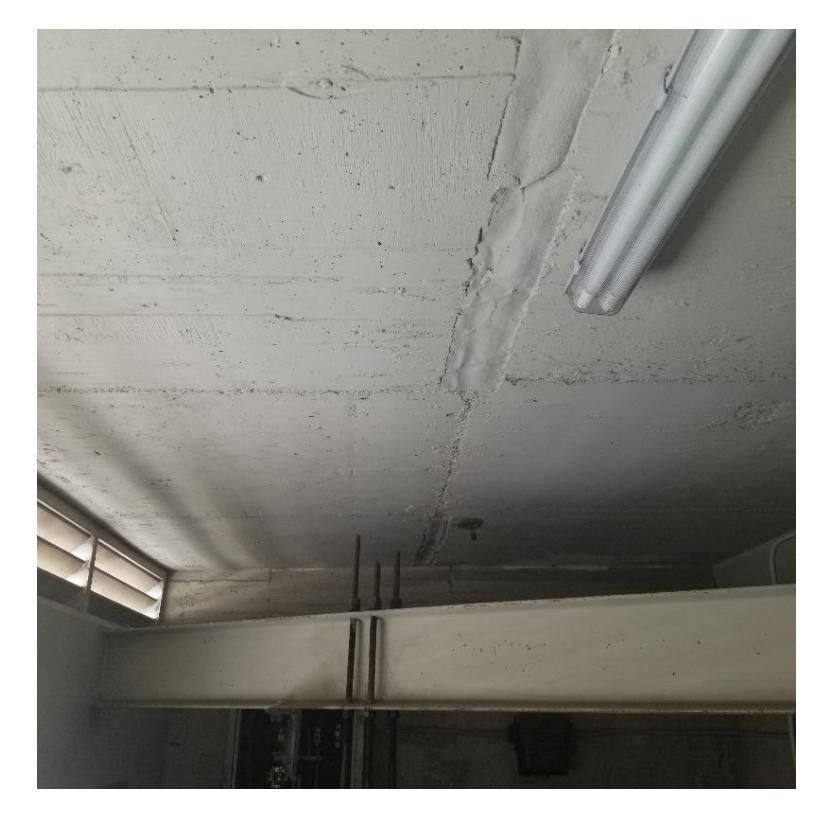
Image 44: Showing Minor Operations Soffit showing peeling.
